**ATD FOUNDATION SUPPORT TO NAKAWA COMMUNITY SCHOOL**  
**BOREHOLE AND VIP LATRINE INSPECTION REPORT**

**November, 2018**

**NAKAWA COMMUNITY SCHOOL**

**REPORT BY LIUWA NAMAKANDO**

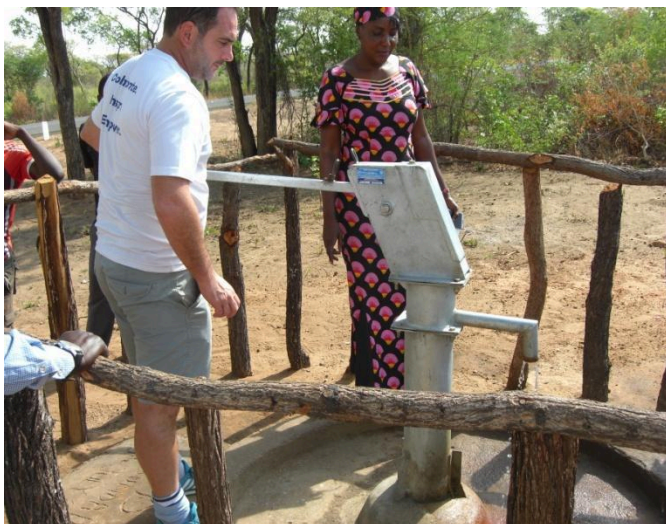
The Community School sourced its water from the neighbouring village which is about 1.5 km away from Nakawa. Through ATD Foundation partnership a borehole was drilled and equipped with a hand pump to provide clean and safe drinking water for the school. The maximum yield of the hand pump is 5 litres per second.

1. ATD Foundation C.E.O inspects the hand pump

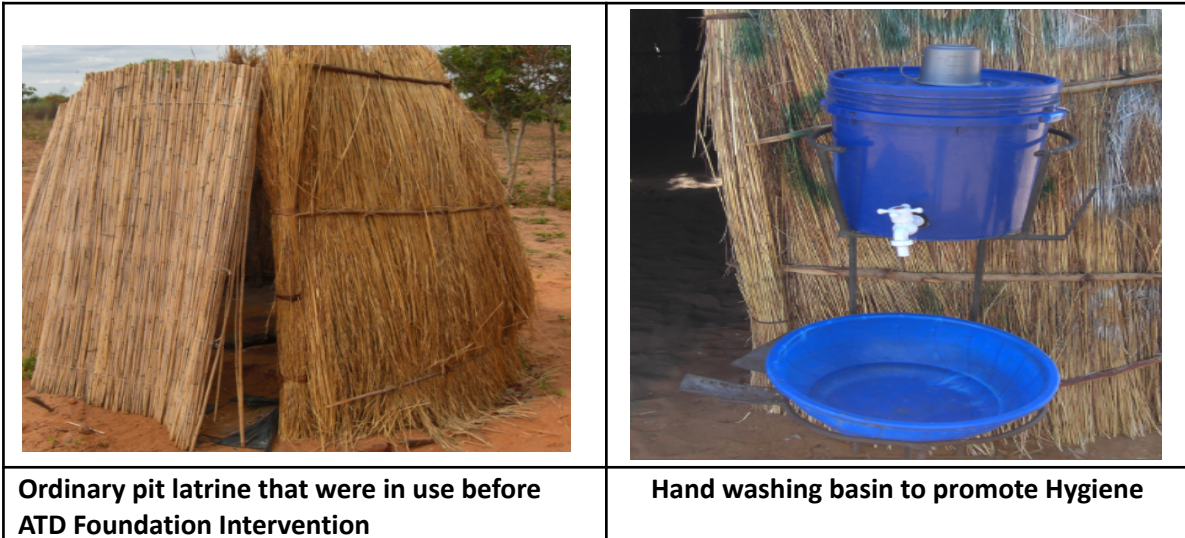
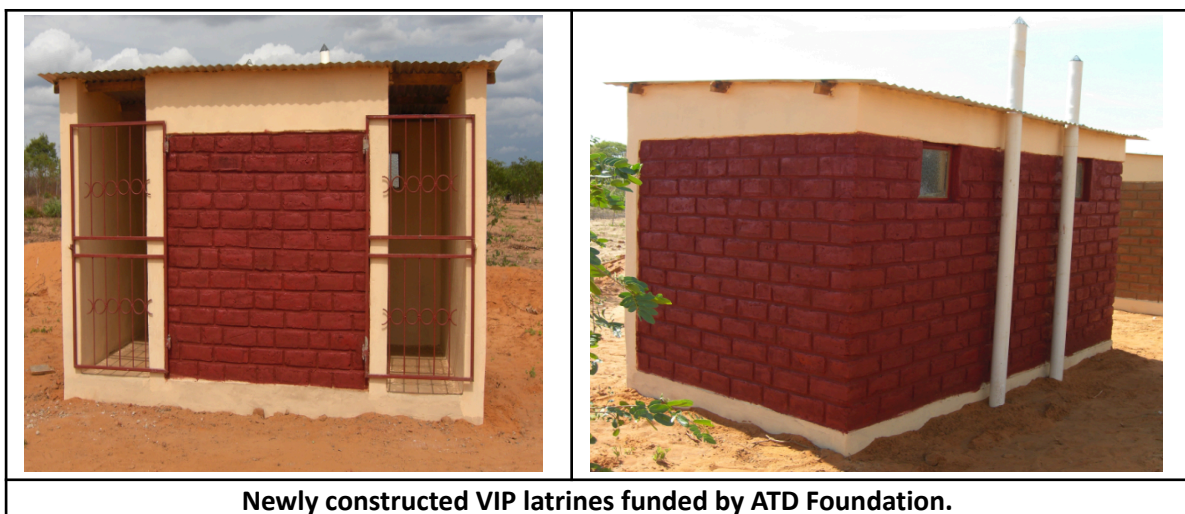
ATD Foundation has built 2 VIP latrines for the community school of which one latrine is a 1x2 and the other one is single. The VIP latrines have been built to standard; all the major components of the latrines were properly done i.e. the ventilation pipe with the wire mesh on top to restrict the flies from leaving and entering the latrine.

Currently the entrances to the pit latrines are not convenient for pupils with disabilities. There is need for ramps and grab rails if the pit latrines are to be accessible to pupils with disabilities. In the regard at least one pit latrine should be equipped with ramps and grab rails to cater for persons with disabilities.

- It is important that convenient hand-washing facilities are provided alongside VIP latrines. The containers should always be full of water and making sure that soap is always available, and should be added to the responsibilities of staff and the chores allocated to pupils.
- It is advisable to have a black vent pipe on the VIP latrines. The ventilation mechanism is convection, and it is induced by the sun heating up the vent pipe.
- The school should introduce WASH components in their curriculum as it is a very vital component where sanitation and hygiene is concerned.
- Engage nearby industries for contribution of Soap, Tissue, Book
