**ATD FOUNDATION VISIT TO NAMABONDO AND SIMBUNJI COMMUNITY
SCHOOLS**

INSPECTION REPORT

MARCH, 2019

REPORT BY LIUWA NAMAKANDO

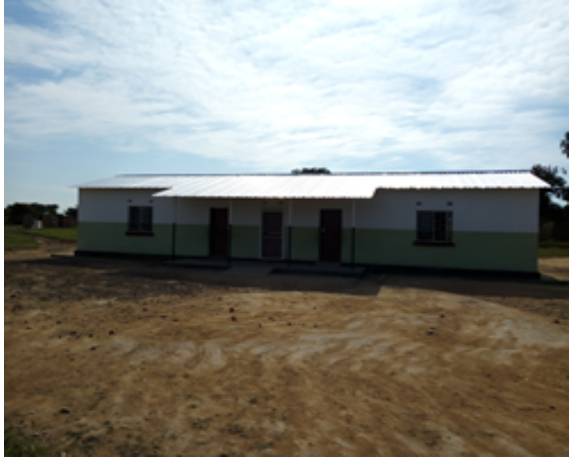
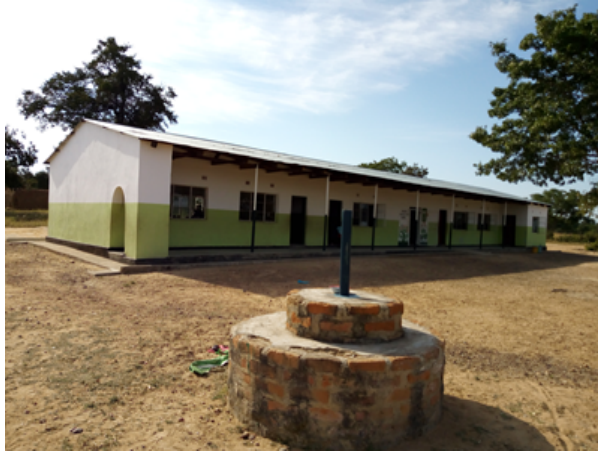
The ATD Foundation is constructed a 1 x 2 classroom block and also funded for the plastering and painting of the other 1 x 3 classroom block.

<p>1 x 2 Classroom block constructed by the ATD Foundation</p>	<p>1 x 3 Classroom block plastered and painted by the ATD foundation</p>

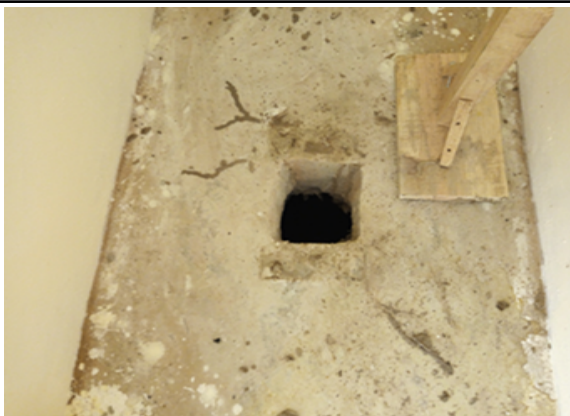
- The hand washing basin had dirty water, contradicting the hygiene principle of washing hands with clean water.
- During the visit, there was no soap at the hand washing stations, despite school authorities charging a K5 termly fee per pupil which is meant for buying soap and toilet paper.
- There was no toilet paper in the latrines despite pupils contributing towards purchase of them same.
- There were no access ramps, these are needed especially for wheelchair access for persons with disabilities
- No grab rails, these are needed for the physically challenged.
- The ventilation pipes for the latrines were not painted black as per standard
- The wire mesh on the ventilation pipes were not properly installed as per standard.
- No floor slopes in the latrines as per standard. Latrine floors are supposed to slope towards the hole.

The inside of one of the Latrines without floor slopes

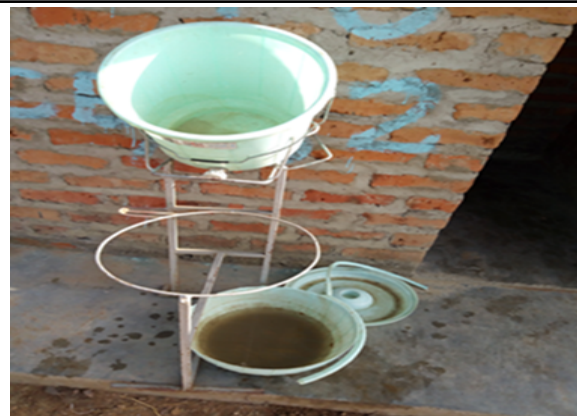
The hand wash station with dirty water and no soap

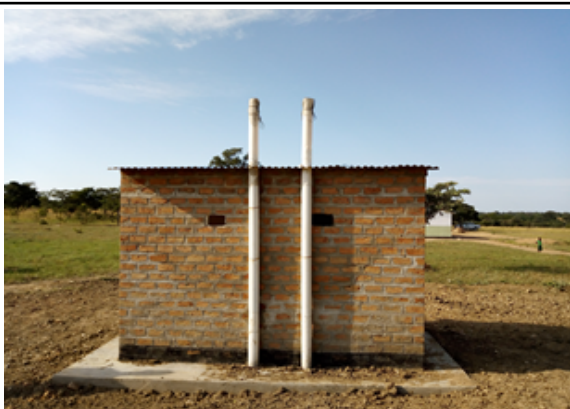
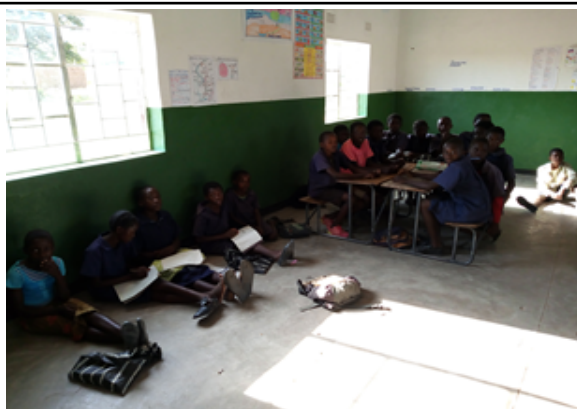
- Namabondo Community School has no access to clean drinking water, no borehole at the school.
- Only one qualified teacher despite the school running from pre-school to grade 7.
- Pupils are subjected to learn whilst seated on the floor due to the limited number of desks at the school

Ventilation pipes not painted black	Desks not enough to cater for all pupils
-------------------------------------	--
